# Floating Breakwater Field Experience, West Coast

MISCELLANEOUS REPORT NO. 82-5

JULY 1982

U.S. ARMY, CORPS OF ENGINEERS  
COASTAL ENGINEERING  
RESEARCH CENTER

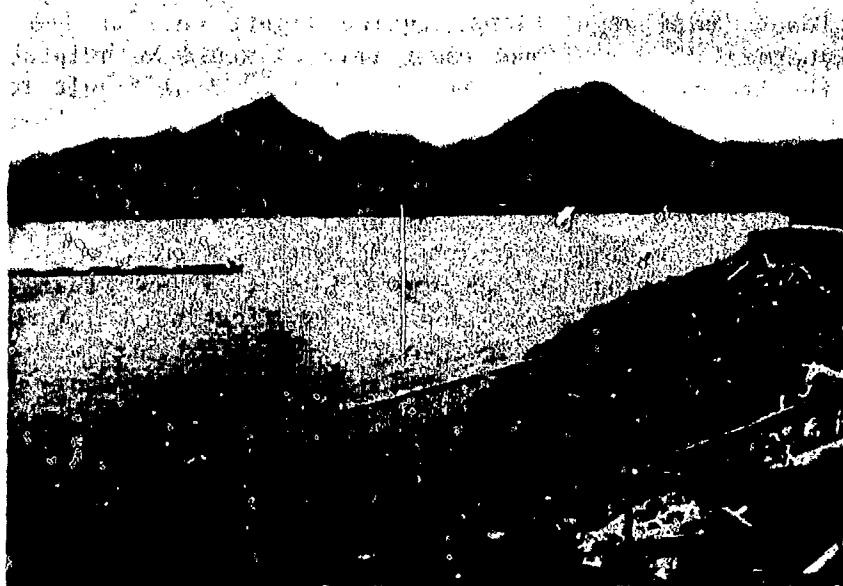
a. North end of harbor.

Figure 5. Photos of gaps at both north and south of harbor, Ketchikan, Alaska.

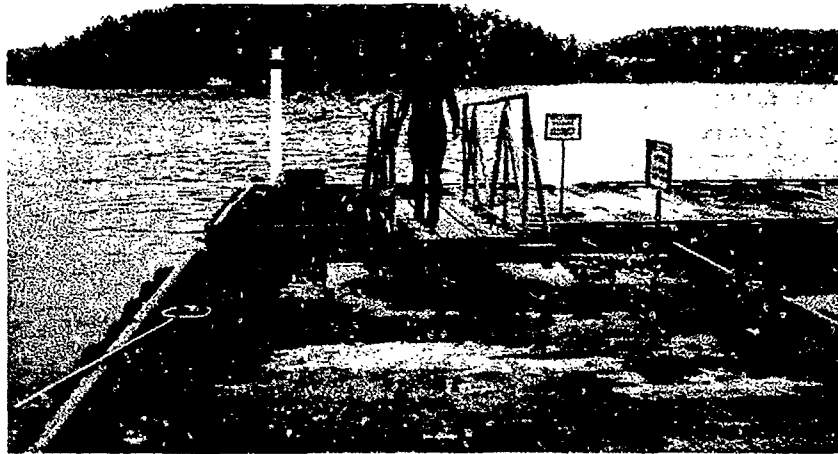
Some adjustments in the breakwater were necessary after installation. The gangways between the sections had to be redesigned to provide greater freedom of movement to avoid being overstressed. One of the sections did not

b. Gangway between sections.

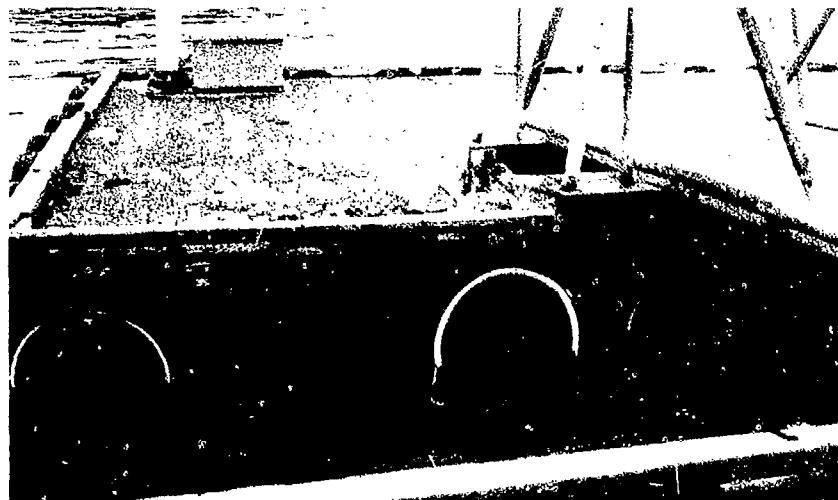
c. Bull rail detail.

The 2- by 4-inch tie piece on the bull rail is too light for its purpose and has broken in a few places. This member should be at least 4 by 4 inches. The installation of the anchors required extra, expensive site preparation which might have been avoided with more informative foundation surveys and better matching of anchor type to bottom conditions. No special maintenance problems have developed.

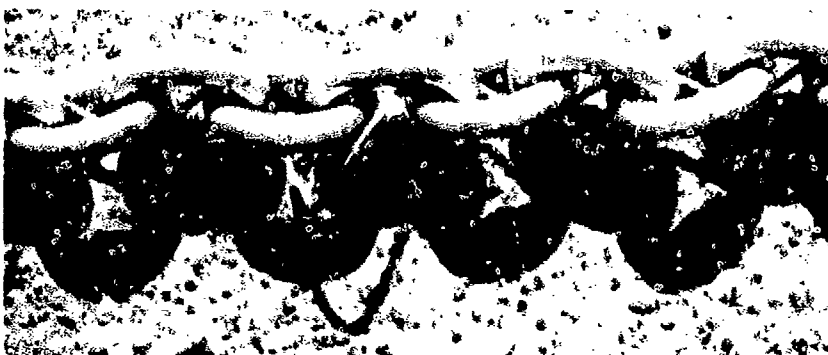
c. Replacement anchor line.
